COVE CREEK WATERSHED MANAGEMENT PLAN

BROAD RIVER WATERSHED

June 2007

**COVE CREEK WATERSHED MANAGEMENT PLAN
EXECUTIVE SUMMARY
NC Ecosystem Enhancement Program**

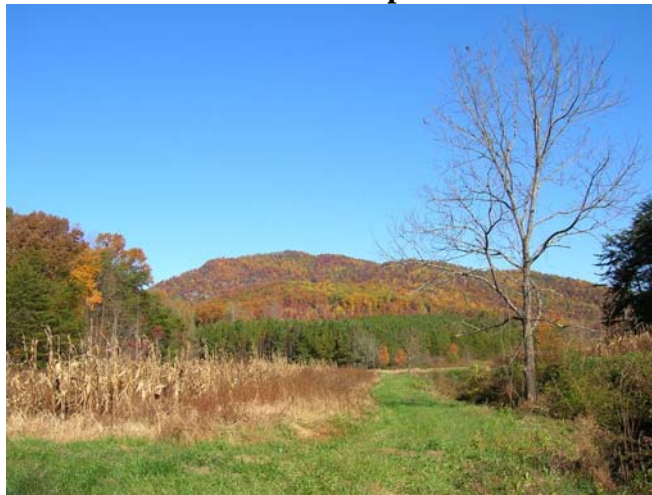
Exhibit 1. Field Cleared up to Stream Bank.

Agricultural and cleared lands account for 4,189 acres or 8% of the land area in the 32 subwatersheds. Based on field observations, the main forms of agriculture are cattle, corn and nursery stock. Other cultivation land uses, such as gardens and silvicultural operations, are present to a lesser extent. When fields are cleared all the way to the stream banks (**Exhibit 1**), the very narrow or complete absence of wooded buffers contributes to the following areas of functional degradation:

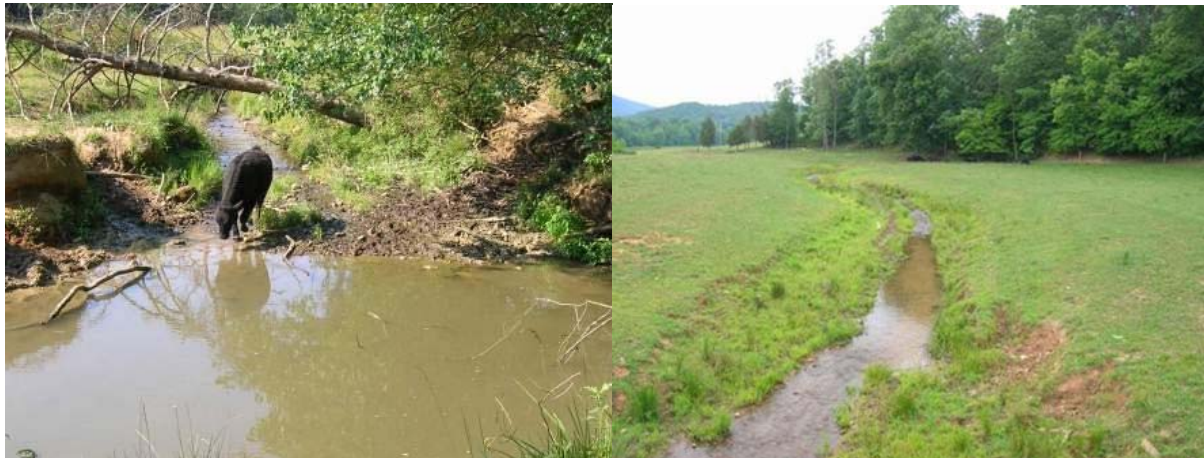
Exhibit 2. Livestock Access to Stream and Buffers Absent.

Numerous cattle operations and horse pastures were observed in the 32 subwatersheds. The majority of these operations are located in the Cove Creek Subwatersheds COVE03, COVE08, COVE09 and COVE11. All of these sites possess pastures with stream buffers that are very narrow or completely absent. Those that have fencing adjacent to streams often have cattle crossings through the streams (**Exhibit 2**). The trampling of the banks by cattle causes instability and erosion, which leads to excess sediment inputs. If pastures are not well-managed and are overgrazed, upland erosion can also add to sediment inputs. Excess nutrient inputs result from fecal contamination rather than fertilizer.
